TENNESSEE DEPARTMENT OF TRANSPORTATION
EROSION PREVENTION/SEDIMENT CONTROL
INSPECTION REPORT

TDOT EPSC INSPECTION FORM Rev. Feb 2010

State Route (SR) / US Route or Road Name and Description: Wolf River Blvd.			Are corrective actions required by this inspection report (Y/N): YES			
County(ies): Shelby	TDOT PIN: 101615	NPDES Permit (NOC) #: TNR153299	Number of New Corrective Actions: 7	Number of Recurring Corrective Actions: 0	Number of New Sediment Releases:	Number of Un-Corrected Sediment Releases:
TDOT Construction No.: 7994-1535-54	TDOT Contract No.:	Contractor: Acuff Enterprises Inc.

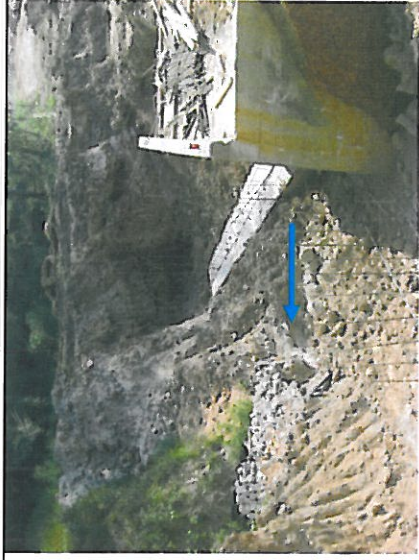
Outfall 10 C Sta. 85+50 LT & Outfall 10D Sta. 84+50 LT
Excavation made for proposed headwalls.
Active construction zone. (FM)

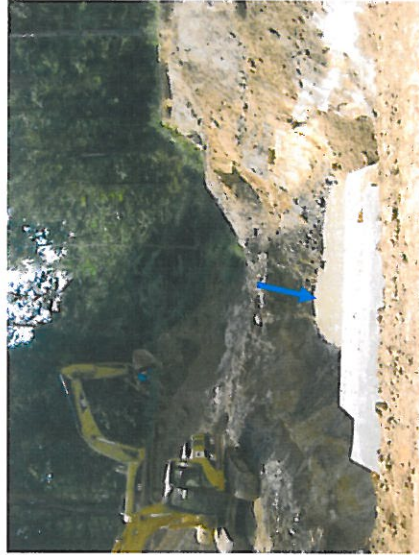
Outfall 11A Sta. 92+50 RT
Active construction zone. (FM)

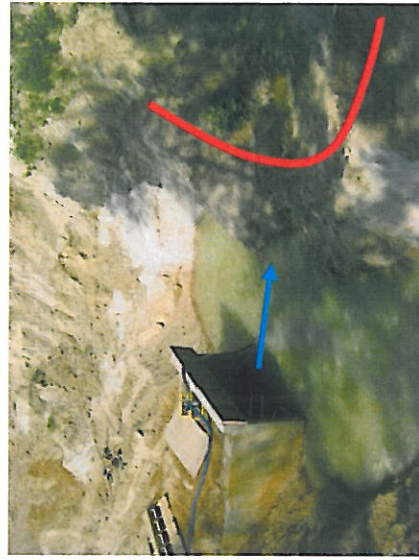
Outfall 11 B Sta. 92+50 LT & Outfall 11 C Sta. 92+00 LT
Re-install RSS (Rock Silt Screen). (FM)

Outfall Name or Station No.	Rain Gage No.	Approx. Station No. From / To	LT, RT or Centerline	Date Last Disturbed	Date of Stabilization and Code T = Temp. P = Perm.	Existing EPSC Control Measure Codes*	Current Condition Codes*	Corrective Action(s) or Comments
9C	2	79+50	LT	8/1/2011	T = 8-2-11	16,20	S	Currently stable. Monitoring BMP's.
10A	2	85+00	RT	8/29/2011	T = 8-11-11	15,16,24,35	FM	Currently active construction site.
10B	2	85+00	RT	8/29/2011	T = 8-11-11	15,16,24,35	FM	Currently active construction site.
10C	2	85+50	LT	8/29/2011	T = 8-8-11	16,35	FM	Excavated for proposed headwall wing. See Photo
10D	2	84+50	LT	8/29/2011	T = 8-8-11	10,16,35	FM	Excavated for proposed headwall wing. See Photo
11A	2	92+50	RT	9/1/2011	T = 8-11-11	15,16,24,35	FM	Currently active construction site. See Photo
11B	2	92+50	LT	9/1/2011	T = 8-11-11	10,32,35	FM	Re-install new RSS (Rock Silt Screen). See Photo
11C	2	92+00	LT	9/1/2011	T = 8-8-11	32,35	FM	Re-install new RSS (Rock Silt Screen). See Photo

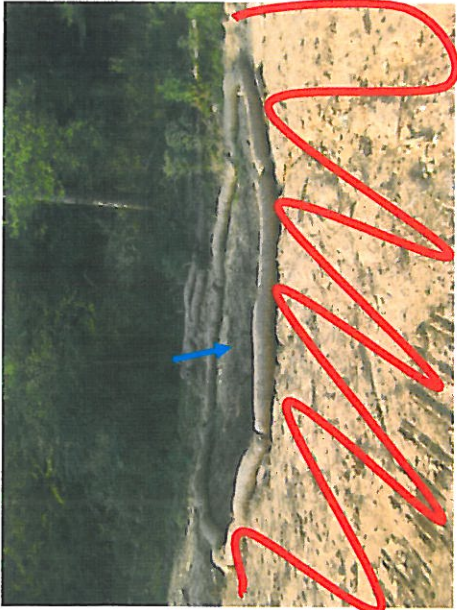
<p data-bbox="669 1029 699 1170">Sta. 15+60 RT</p> <p data-bbox="697 915 726 1338">Re-grade to remove rills and re-stabilize. (I)</p>	<p data-bbox="409 415 438 532">No Picture</p>
